T-489  
Defender House  
Trappe vicinity  
Private

# Maryland Historical Trust State Historic Sites Inventory Form

and/or common Defender House

Survey No. T-489

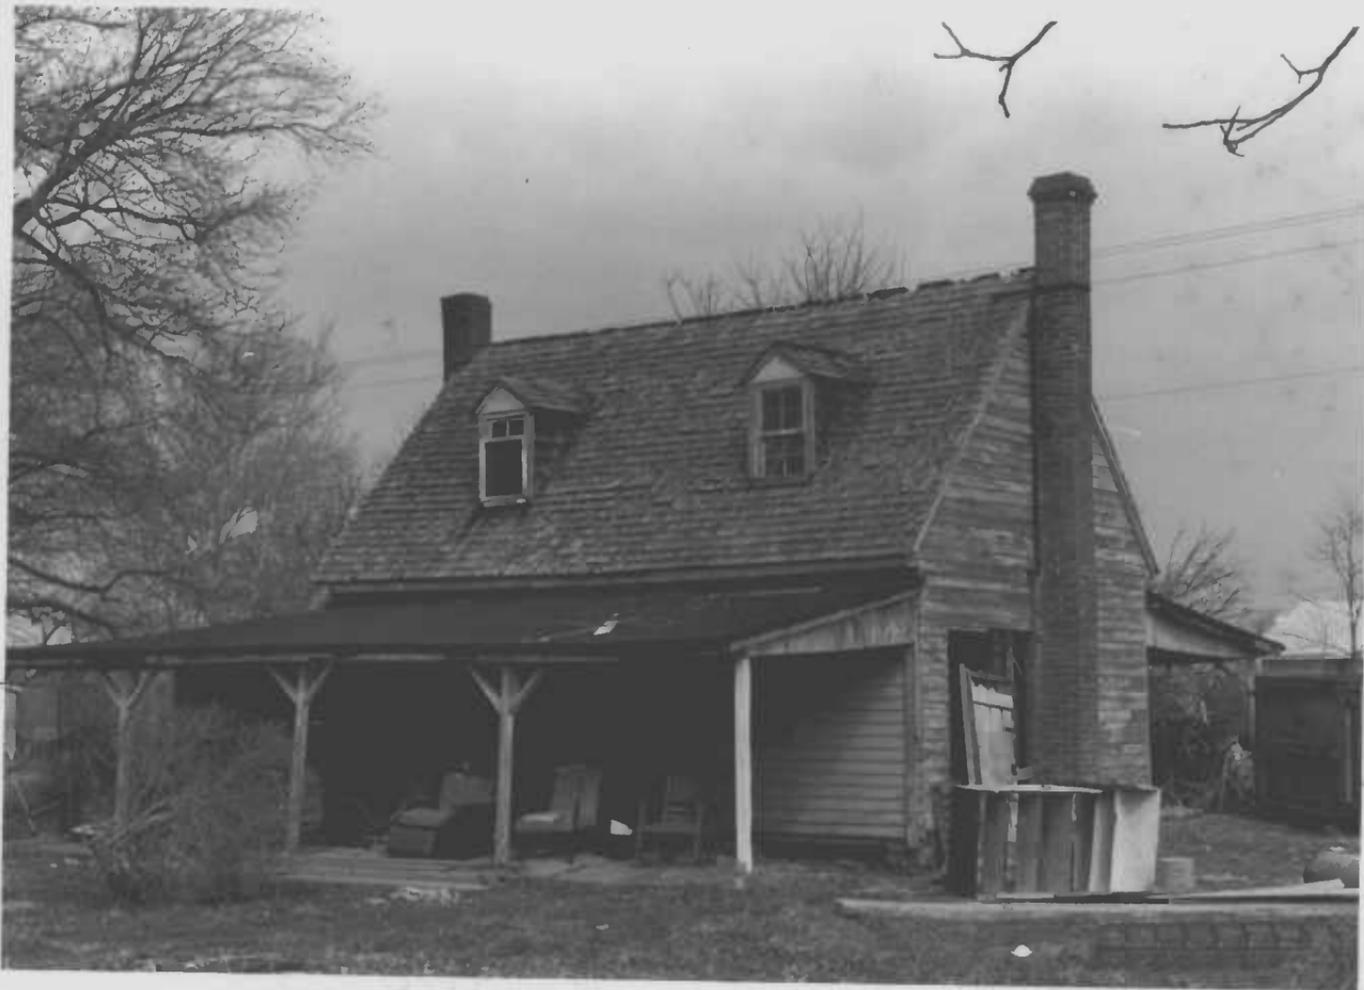
T-489 Defender House  
Trappe vicinity  
Orlando Ridout V March 1982  
South Facade

The rear facade is similar to the front facade, with a door near the center flanked by a single 6/6 window on each side. There are two pitched roof dormer windows on this facade. The east dormer is fitted with early 4/4 sash; the west dormer has later 2/2 sash. Both dormers are trimmed with the ogee backband crown molding found on the front dormer. The majority of the siding has been replaced; the cornice and roof match the front facade.

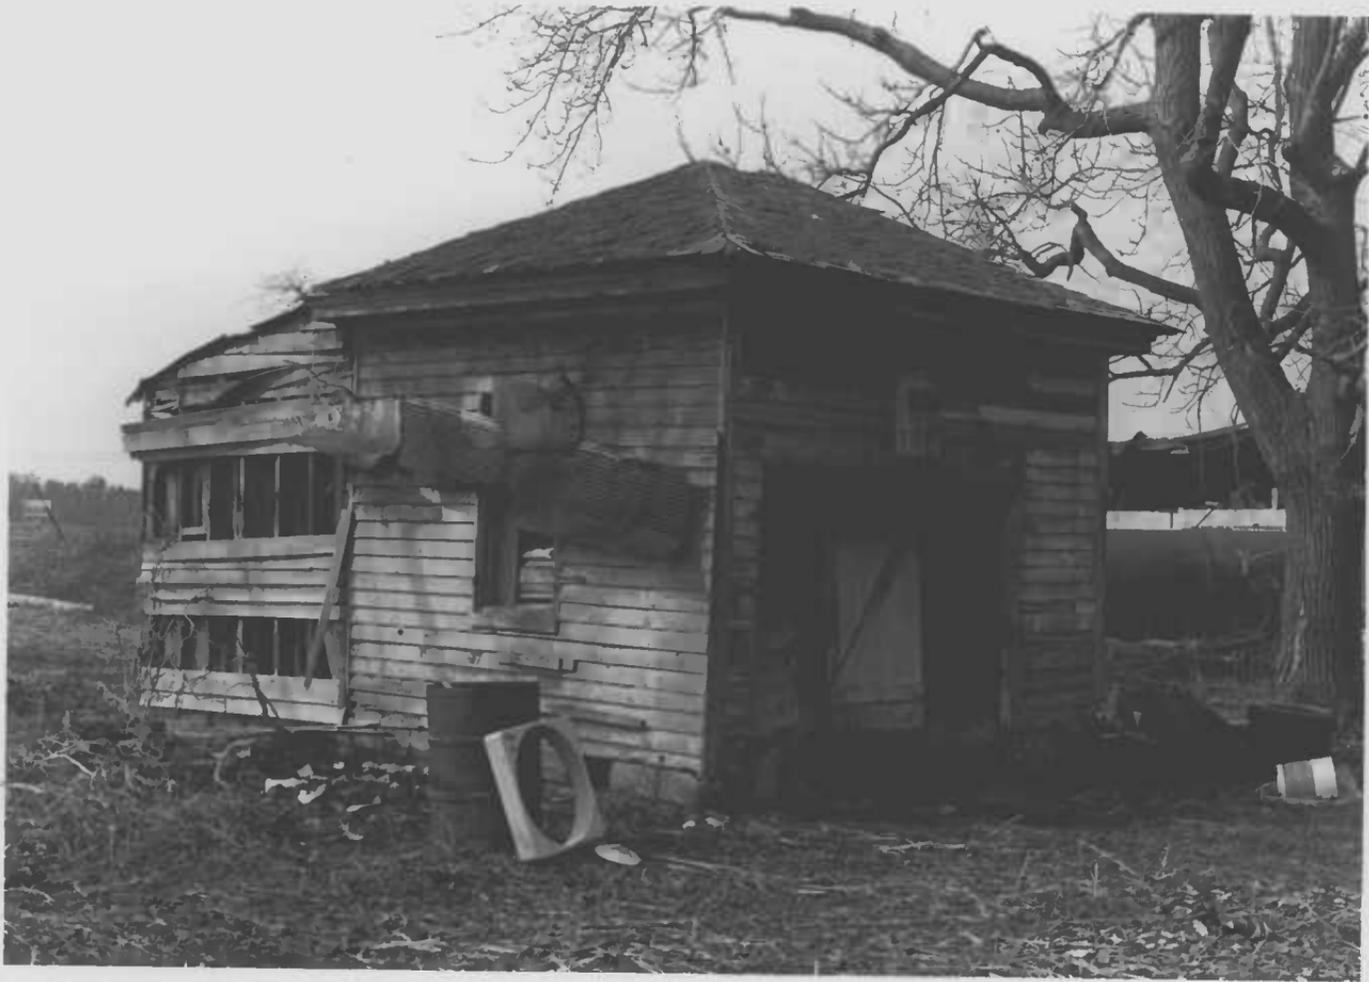
T-489 Defender House  
Trappe vicinity  
Orlando Ridout V March 1982  
Outbuilding

Outbuilding: A small frame outbuilding is located approximately 50 yards to the south of the house. This building measures 12 feet by 13 feet and was also moved to this site, presumably from Trappe. This nearby square building with a hip roof has been altered by large openings cut in the north and south wall. Original window openings remain visible on the east and west walls. The eaves are boxed in and trimmed with a handsome complex crown mold of the

Greek Revival period and a smaller bed mold. The interior was plastered with machine sawn lathing secured with machine made nails. The framing members are circular sawn and the studs are close-set. An enclosed stair rises against the west wall to a small loft space. The original ceiling joists have been cut out and a later, lower ceiling has been inserted.

The original function of this building is unknown. The size of the building and the close-studding are typical of meat houses in this region, but the plastered walls and original windows suggest a more formal use such as an office. The circular sawn framing timbers, machine sawn lathing and Greek Revival cornice suggest a date of circa 1850s.

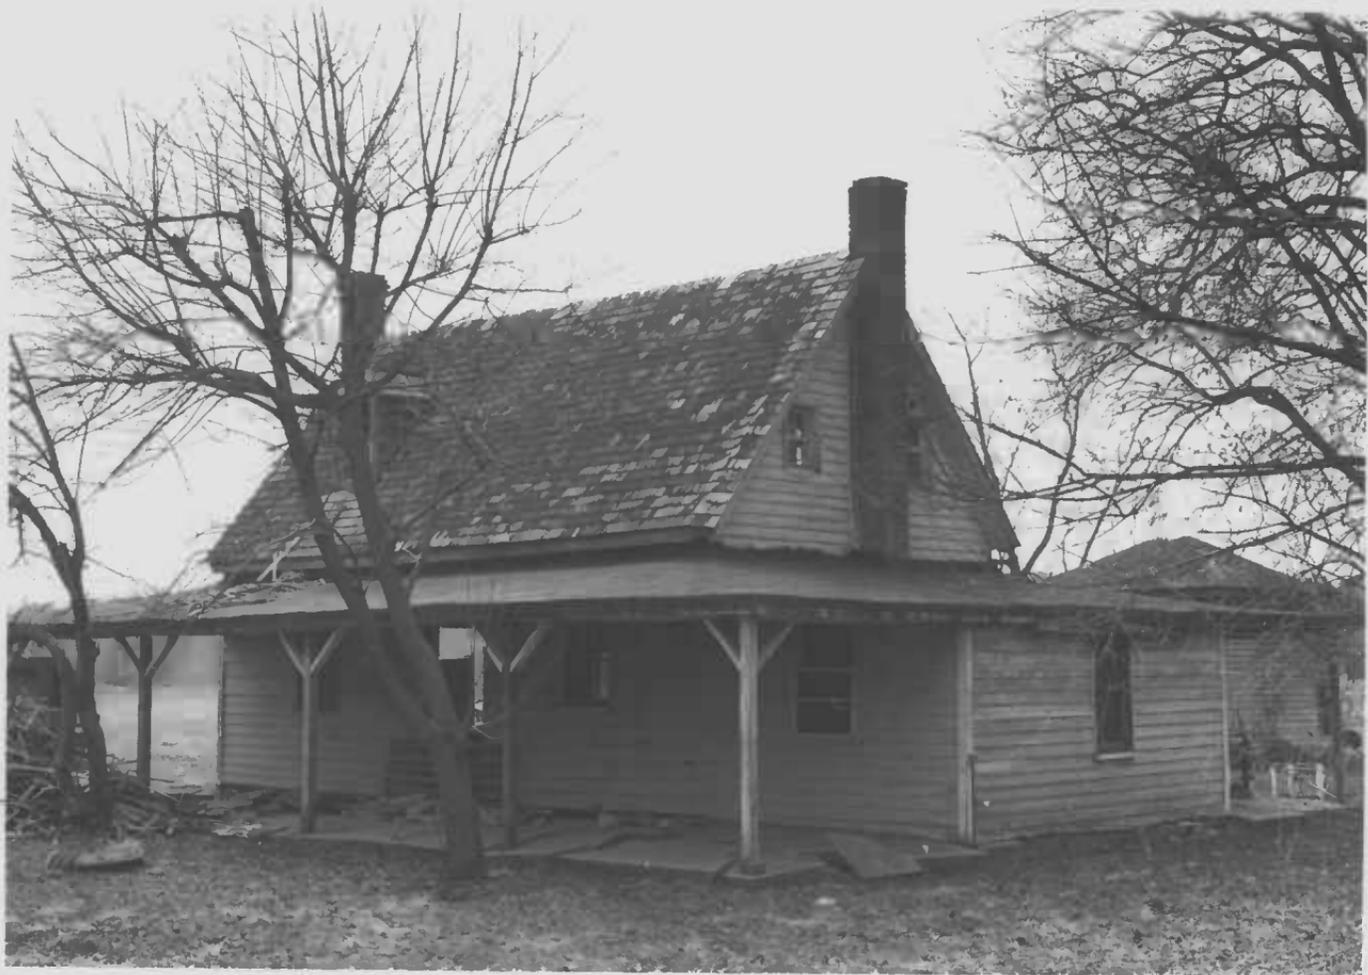
T-489 Defender House  
Trappe vicinity  
Orlando Ridout V March 1982  
North Facade

The north or front facade of the house faces Back Town Road. The principal entrance is located in the center bay of this facade flanked by a single 6/6 window on each side. One pitched roof 4/4 dormer window is located in the east bay on the second floor. The windows are set in beaded frames. Early wide, random-width weatherboard siding survives on the upper portion of this facade; the lower wall is sheathed with later plain siding. The eaves are boxed in and trimmed with a small crown mold applied against a beaded fascia; the roof is covered with wood shingles. The dormer window in the east bay is trimmed with an ogee backband trim framing the opening and a complex crown mold in the pediment.

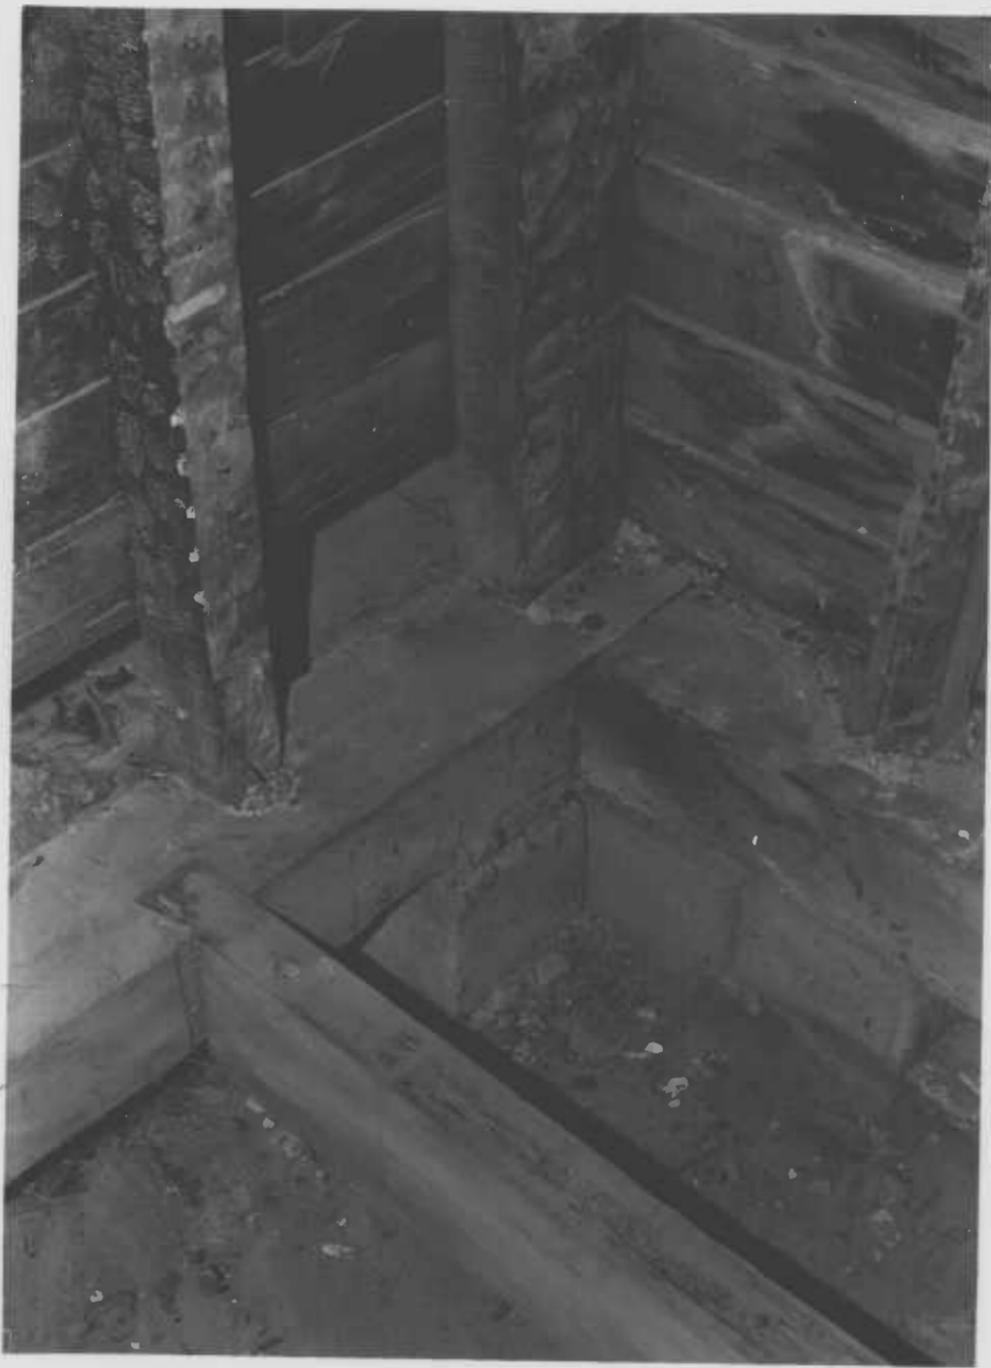
T-489      Defender House  
            Trappe vicinity  
            Orlando Ridout V    March 1982  
            Dovetailed joints/sill  
            connection

The interior framing of the house has been exposed by a renovation project now underway. The door and window openings on the front and rear facades and the east gable are clearly original, but the door in the west gable wall, opening into the lean-to, is cut-in. The first floor joists are dropped into sockets in the facade walls and are not pinned. Joists at either end and near the center of the building are dropped into dovetail slots, securely tying the frame together. The framing exposed in the first floor stair closet was whitewashed but never plastered. Early trim on the first floor includes beaded baseboard, beaded architrave trim with ovolo backband, and beaded window sills with a simple Federal nosing.

The renovation of the house now underway has exposed a number of interesting framing details, including clever dove-tailed joists that tie the front and rear walls together.
